Reconnaissance Survey of the Depot District and Old Town Neighborhoods

Kirksville, Adair County, Missouri

Owen & Eastlake Ltd.

City of Kirksville, Kirksville, Missouri

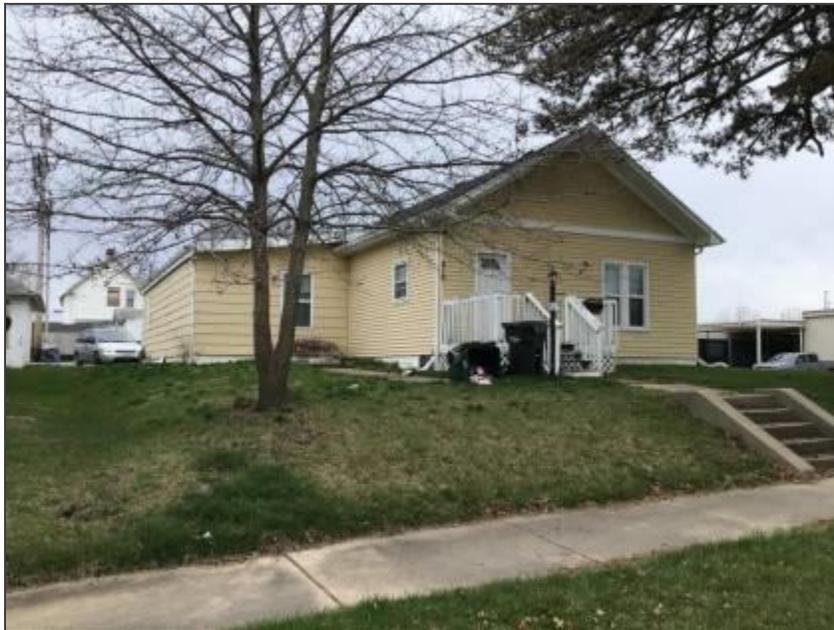
Figure 17. Gable Front Form (615 N. Elson).

The gable front type is a simple housing form found in many regions of the United States. This type arose as a folk housing form earlier in the nineteenth century and remained popular as railroads brought mass production and standardization to the building industry. In Kirksville, earlier subtypes include simple one-story gable-front houses or two-story examples. Kirksville examples commonly have a front porch with a shed, hipped, or gabled roof. Kirksville also has examples with a recessed front porch incorporated into the main roofline. In Kirksville, before about 1905, smaller one-story examples of this house type either had little or no stylistic detail, or had modest classically-inspired or Victorian/Queen Anne detailing. Larger two-story examples were larger and more expensive homes, and were often adorned with more detail. After 1910, the one-story version of this house in Kirksville often takes on forms and detailing of the Craftsman style, including lower roof pitches, overhangs, exposed rafter tails, and knee braces. A small gable-fronted Craftsman bungalow, usually with a gabled front porch, is probably the most common pre-1930 Kirksville housing type, appearing all over the city's older residential areas.

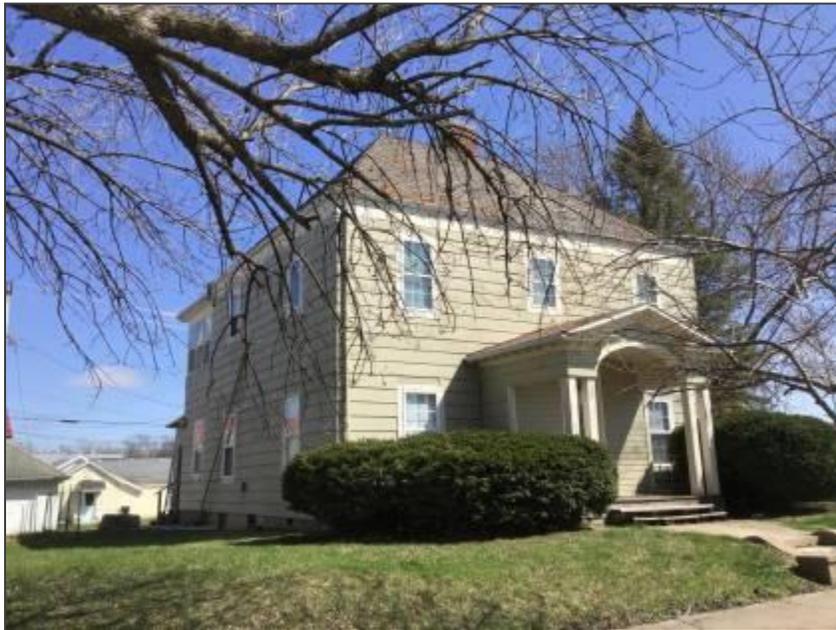
Figure 18. Central Passage Form with Colonial Revival Porch.

In a more narrow sense, this simple folk housing form is a one-story house with a side-gabled roof and an entrance in the center of the facade. The houses are two rooms in width, and the main gabled portion is one room deep, often with a shed-roof rear wing addition. The type originated as a traditional English housing form and was common in the southeastern United States during the pre-industrial era. The “central passage” term is also used in this study to denote any one or two-story house with a central front entrance that is at least two rooms wide, and that does not fit into any of the other major housing types/categories listed in this study. Kirksville has some simple examples of early vernacular examples of the more narrowly defined central passage type, as well as many later examples of houses that fall into the wider category.

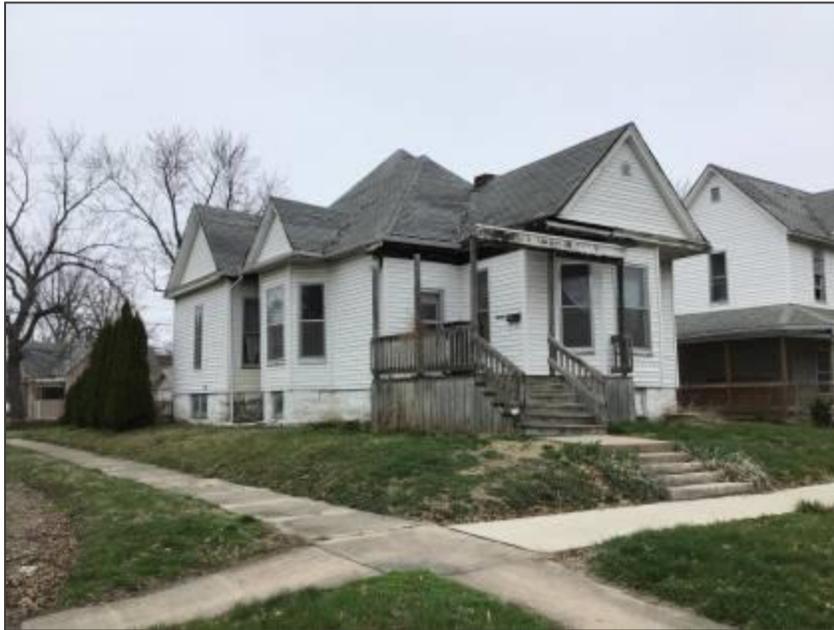
Figure 19. Queen Anne Form (501 E Washington).

Queen Anne represents both an architectural style and an approach to house planning and layout. The style and form are inspired by Medieval architecture and emphasize complexity and asymmetry. The house facades often feature elements such as three-sided bays, turrets/towers, and varied window shapes and sizes. Ornament consists of contrasting textures and shapes, including use of both wood siding and shingles, as well as shaped claddings like fishscale shingles. Other ornament includes porch ornaments like spindles, scroll-saw tracery, and turned posts. Examples can be one or two stories tall. Kirksville has a number of typical asymmetrical examples with turrets, bays, and gables projecting out from a central hipped roof. The city also has a number of distinctive examples that have symmetrical facades with multiple three-sided bay windows and diagonal angles at the corners, giving an octagon-like effect.

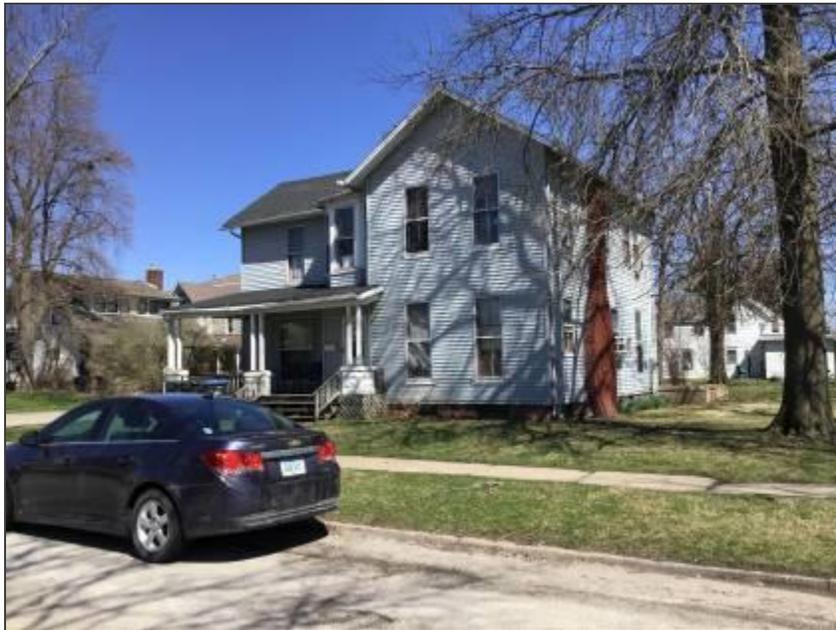
Figure 20. Gabled Ell Form (301 S. Florence).

This type of house is typically two stories in height, and has a wider section of roof, often hipped or cross-gabled, at the rear, and a narrower section of gabled roof on the front. The facade is then composed of the main gabled section and a recessed area on one side. A porch is often placed in front of the recessed area. These houses are common in densely developed cities in the Midwest. The format was used by builders at the end of the nineteenth century and in the early twentieth. Stylistically, these houses may be plain folk-style examples or reflect a range of historical styles from Italianate to Queen Anne to Colonial Revival. Kirksville examples tend to be plain in design or reflect Queen Anne, Neoclassical, or Colonial Revival stylistic influence. In Kirksville, this format becomes less common after about 1910, supplanted by newer housing formats like the American Foursquare.

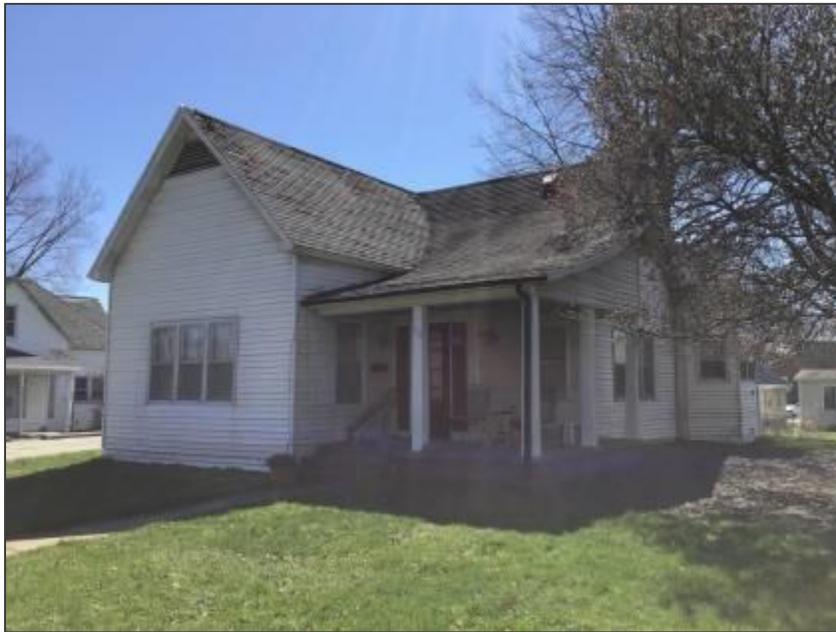
Figure 21. Gable and Wing Form (701 E. Harrison).

Like the gable front housing form, the gable and wing type also had origins in pre-industrial times and appears in many locations throughout the United States. The form consists of a typical gable-front house that also has a side-gabled wing, placed to the right or left. This is one of the most common housing types for pre-1910 Kirksville, with examples seen throughout the project survey area. Kirksville examples commonly have a front porch with a gabled, hipped, or shed roof. Examples tend to have little or no stylistic detail or have somewhat sparse elements of Victorian/Queen Anne detailing, which often takes the form of porch features such as spindles or turned posts. However, Kirksville also has several examples of this housing form with more elaborate high-style Queen Anne or Carpenter Gothic detailing. Pre-1915 Kirksville housing features both one-story and two-story examples of the form, although the one-story format seems especially common. In Kirksville after about 1915, it appears that the one-story version of this small house type was largely replaced by the gable-front Craftsman bungalow as the favored small house type.

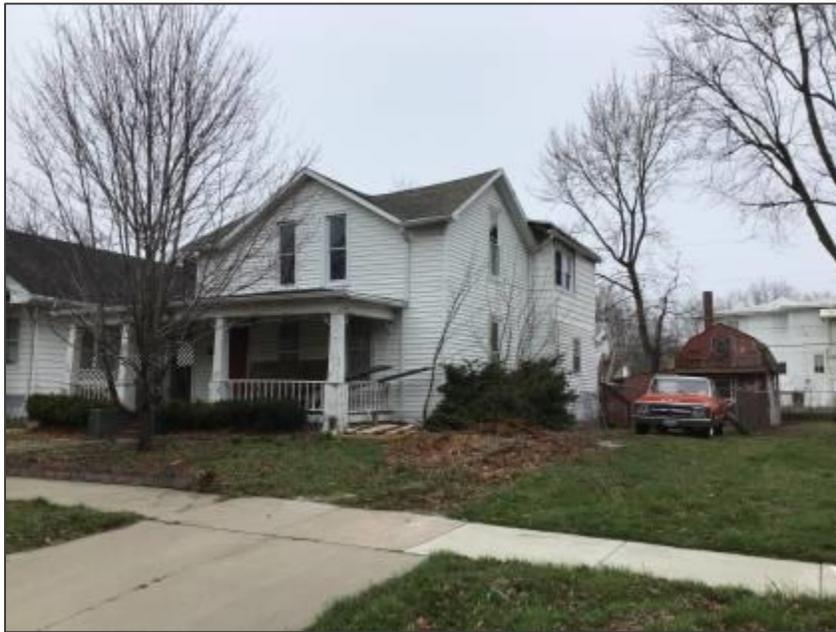
Figure 22. Center Gable Form with Craftsman Porch Details.

This type is related to the gable and wing type, and consists of a side-gabled house with a symmetrically-placed front-facing gable, and a central entrance under the gable. The gable can either be a simple roof gable or can be part of a projecting central front wing. Like the front gable and gable and wing types, it has origins in pre-industrial folk housing. This type was mostly built before 1920 in Kirksville and is not as common as the much-favored gable and wing format. There are two major Kirksville variants of this type. The first variant is a full two-story side-gabled house with a gable and entrance in the center of the facade. The second common variant is a house with a full first story and a shorter second story partially or fully accommodated under the roofline. The central roof gable provides additional space for the partial second story. Examples of both subtypes are plain or have modest Victorian/Queen Anne detail. The one-story version of this format was largely supplanted after 1915 in Kirksville by the gable-front Craftsman bungalow.

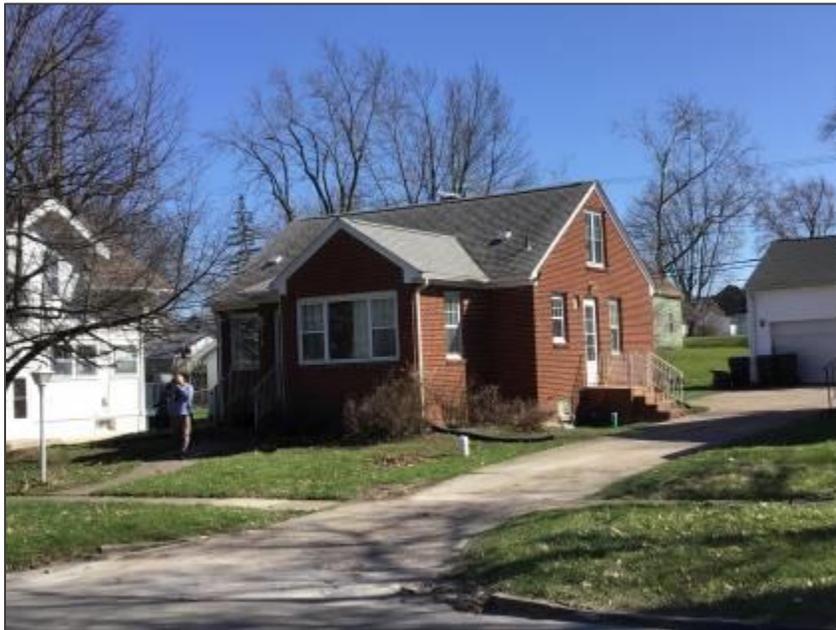
Figure 23. Minimal Traditional Form (904 E. Washington).

This type of house originated with the need for budget-cutting in house construction during the lean years of the 1930s and World War II. These houses are typically simplified and stripped-down versions of the Colonial Revival and Tudor Revival houses popular in the 1920s. The homes usually feature relatively low roof pitches, and the roof designs tend to lack the broad overhangs seen in earlier Craftsman and Prairie housing stock. These features give the Minimal Traditional style a somewhat clipped, boxy appearance. The houses are usually side-gabled or cross-gabled in format, although Kirksville also has a few hipped-roof versions. These houses are usually plain with very little stylistic ornament, although a few simple details such as Colonial porch columns are sometimes included. Kirksville examples of this style typically date from 1945 into the 1950s and are similar to examples found in other areas of the United States that experienced postwar-era development. The format was a slightly more traditional alternative to the Modernist-inspired postwar Ranch house.

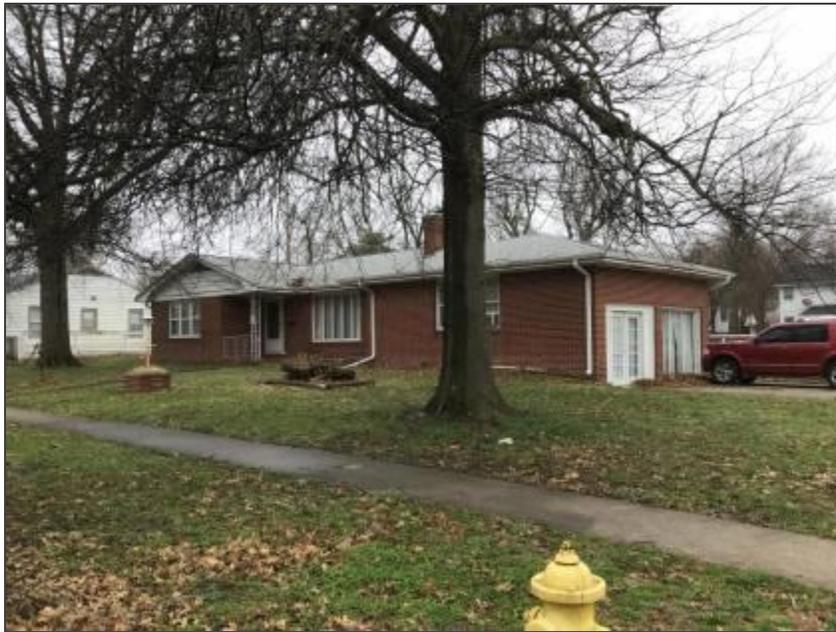
Figure 24. Ranch Form (907 E. Washington).

The ranch house is a one-story home characterized by plain design with little ornament, low rooflines of hipped, side gabled, or cross-gabled design, and a low, horizontal, sprawling format. The ranch house evolved in the 1930s from a combination of Modernist influences and western vernacular house types. Its simplicity, informal character, and ease of construction made it a favorite housing type for postwar real estate developers. A modest number of ranch houses are found in the survey area, and many were infill houses that occupied vacant lots left over in older residential subdivisions after World War II. Kirksville's ranch house examples in the survey area are fairly typical of ranch house construction in the postwar Midwest. Both brick and wood frame ranches exist in Kirksville. Although most examples are plain and fairly utilitarian in design, sometimes a few Colonial Revival or Mediterranean features were incorporated into the exteriors.

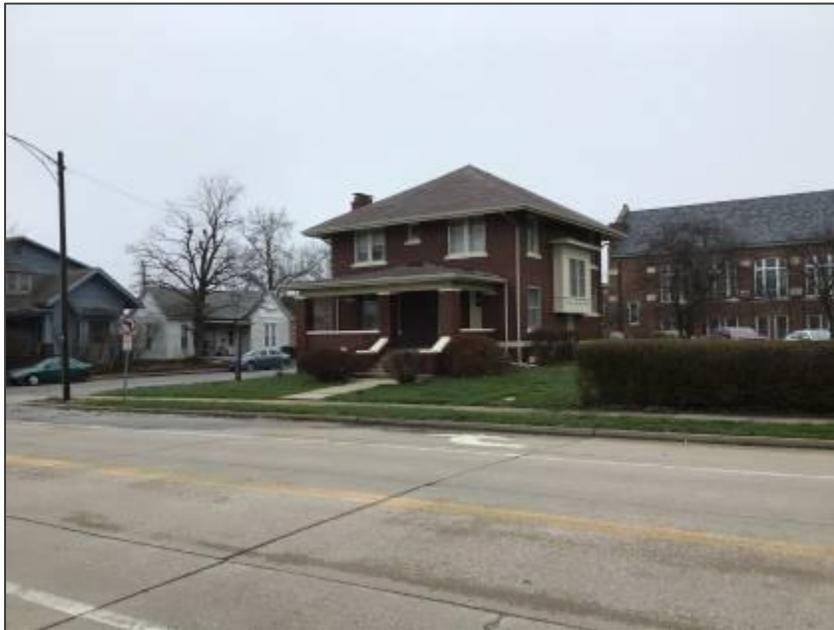
Figure 25. Foursquare Form (301 E. Jefferson).

This housing type is common all across the United States in areas that saw development from about 1900–20. Examples of the type are two-story houses with box-like proportions, low horizontal lines, overhanging roofs with dormers, broad one-story hipped-roof front porches, and largely symmetrical facades. The foursquare form was influenced by the simplicity and horizontality of Frank Lloyd Wright’s early Prairie-style architecture, and this housing format is considered distinctly American due to its Wrightian origins. Examples in Kirksville sometimes have little or no ornament, or a few subtle Craftsman details, in sympathy with Wright’s emphasis on simplicity. However, Kirksville examples also exist that have more stylistic detailing, often taking the form of cornice brackets and various designs of porch supports.

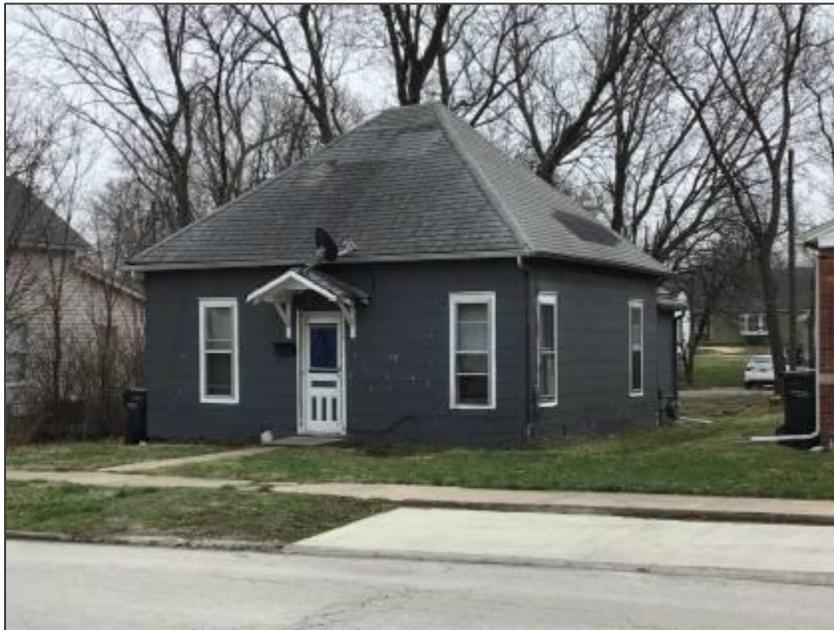
Figure 26. Pyramidal Roof Form (714 E. McPherson).

The pyramid-roof housing format usually involves a small house with nearly square proportions, allowing for the roof to take a pyramidal or near-pyramidal form. This is in contrast to the more conventional hipped roof that would cover a house with a longer rectangular shape. This house form originated in the pre-industrial era but persisted into the twentieth century. The form is most common in the American south and is not seen as much in the northeast and upper Midwest. Its presence in Kirksville may indicate some degree of southern influence in the city's pre-1910 residential architecture. Most Kirksville examples are very small cottages of simple design with little or no stylistic detail and were built before 1920. A few examples were built ca. 1910–30, and they often reflect influence of the prevailing bungalow/Craftsman aesthetic of that era. The pyramid roof form exists in Kirksville but is much less common than the dominant gable front and gable and wing formats seen throughout the city's older residential areas.

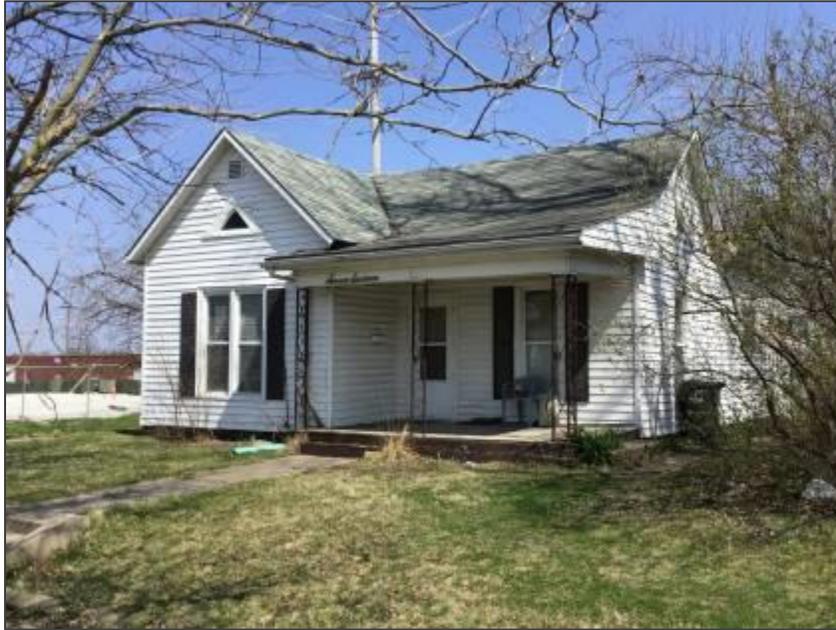
Figure 29. Folk/Traditional Style on Gable and Wing Form (716 N. Elson).

Folk/Traditional style is meant to delineate this utilitarian form from more high-style architecture.¹⁸ Folk/Traditional style reflects the communities' response and history to architecture. In Kirksville Folk/Traditional style can be used on many architectural forms.

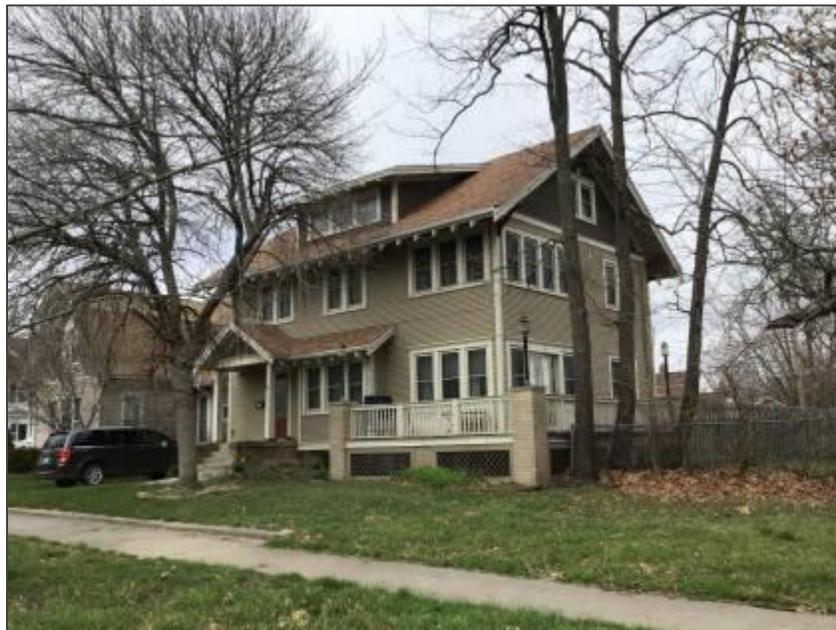
Figure 30. Craftsman Style (407 E. Harrison).

Craftsman-style homes are popular in Kirksville and are the second most common style recorded in the survey. The style evolved out of the English Arts and Crafts movement and originated with the work of Greene and Greene in California in the 1890s. The Craftsman style was most popular from about 1905–30, with a large number of these houses constructed in Kirksville from ca. 1915 through the late 1920s. Houses of this style tend to be side or front gabled in form, and ornament is restrained. Other common features are relatively low horizontal proportions and low-pitched roofs with broad overhangs. Common details include battered porch posts, windows with vertical mullions, exposed rafter tails, and knee braces. Kirksville has at least one high-style two-story Craftsman house (407 E. Harrison), as well as several larger examples of the bungalow type, which is a house form that is either one-story, or has most of the living space on the first floor with additional rooms fitted underneath the roofline.

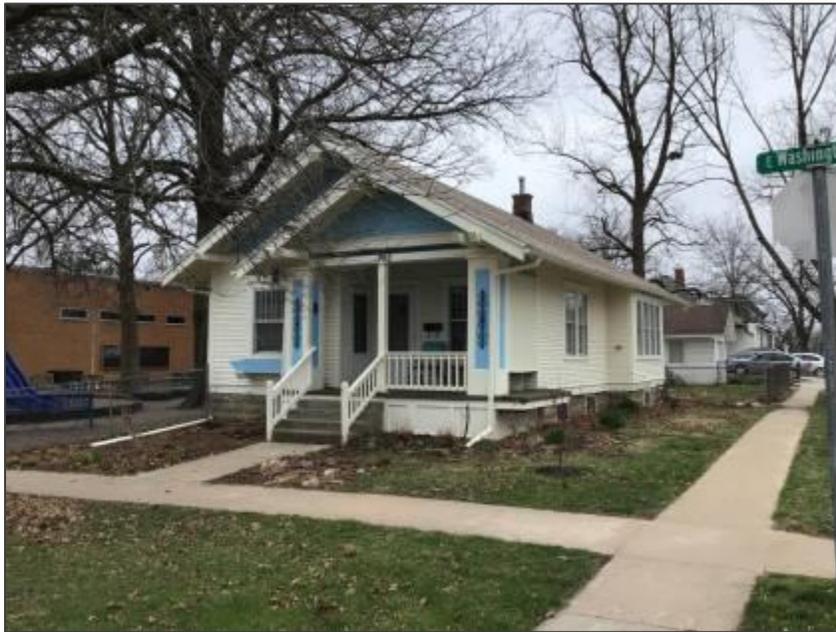
Figure 31. Bungalow/Craftsman Style (702 E. Washington).

The overall features of the Craftsman home are covered in the above “Craftsman” section, and features of larger Craftsman homes are described. However, in Kirksville, the most common Craftsman housing form is a small, gable-fronted, one-story bungalow, usually of wood frame construction, although at least one brick example exists. This type of house is so common in the study area that a separate discussion and classification is warranted. These houses usually have a low-pitched gabled front porch with brick piers or tapered or battered posts, reflecting Craftsman influence. A few of these houses also have recessed front porches that are incorporated into the main roofline. Some examples have other Craftsman details such as vertical-mullioned three-over-one to-eight-over-one windows, exposed rafter tails, and knee braces. Other houses lacking some or all of these details may have been built as plainer examples, or remodeling may have resulted in the removal of some Craftsman details.

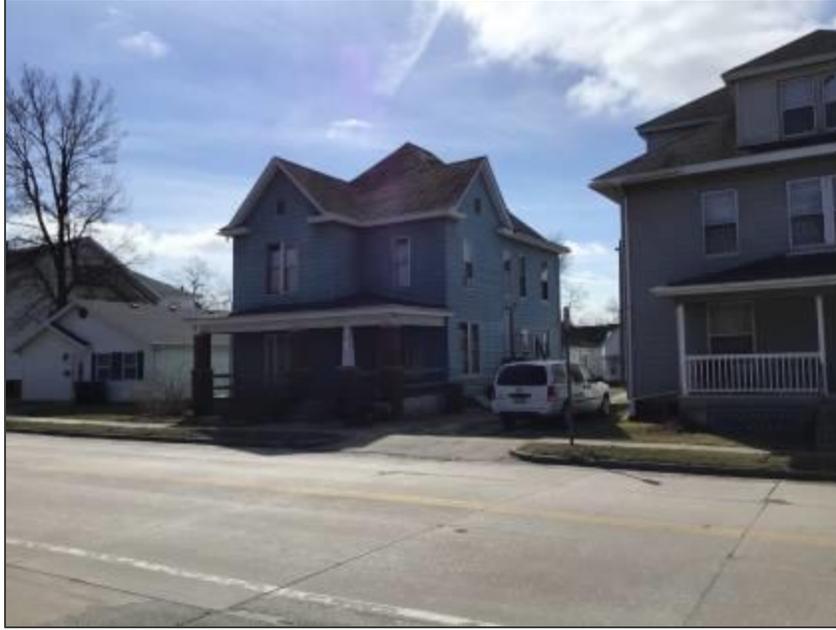
Changes to this style often result in the wrap-around porch being removed. Porch supports and columns are also often switched out, although some high-style examples remain. High-style examples would have turned wood supports, although in some instances classical columns are present.

Figure 32. Queen Anne Style with Craftsman Porch (308 Jefferson).
The porch was a later addition to the building.

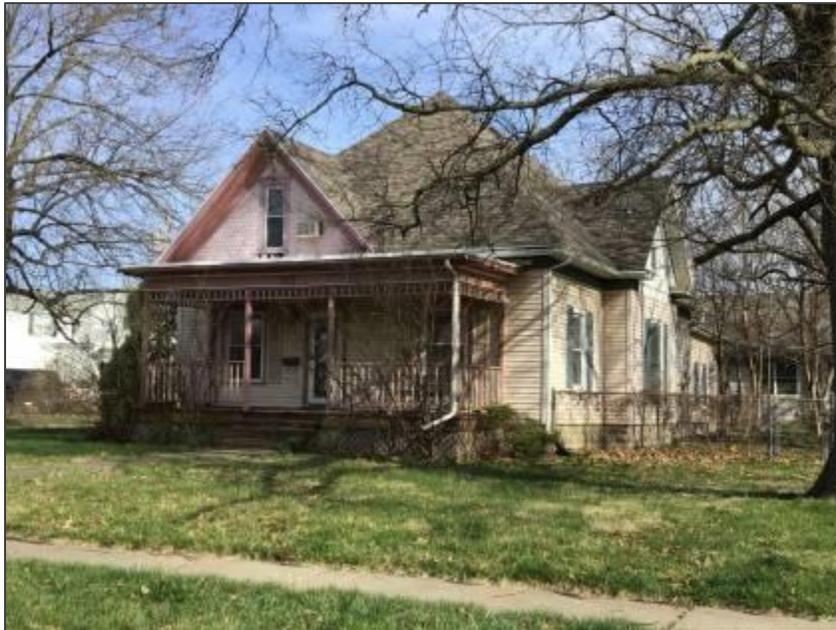
Figure 33. High-Style Queen Anne (701 E. Harrison).
Note the irregular shape and the hip and gable roof.
The porch features turned wood posts and spindlework.

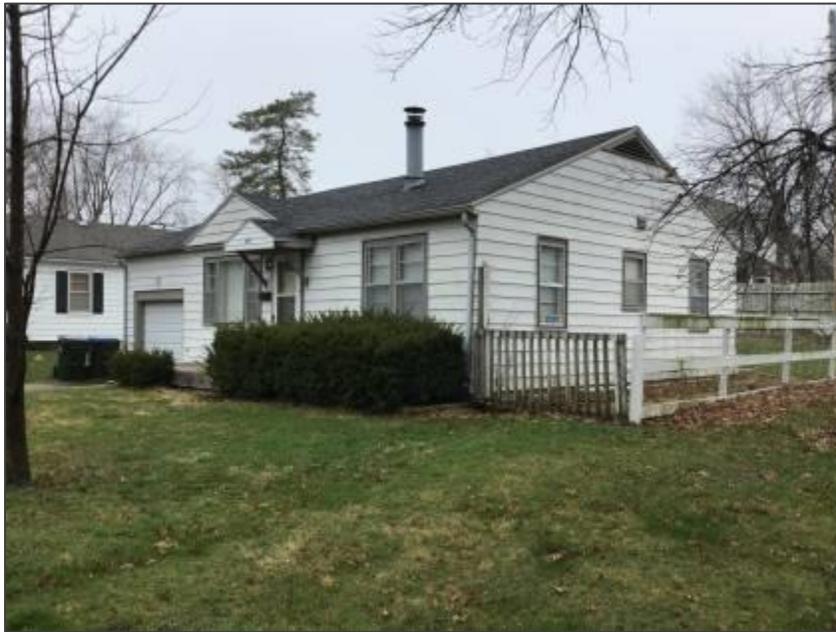
Figure 34. Minimal Traditional Style (903 E. Washington).

Minimal Traditional house forms are based on Federal Home Administration small house designs from the 1930s. The form was popular from 1935–50. Predominant designs include the Cape Cod and gable and wing forms. The houses sometimes have Colonial-inspired elements and forms, but do not have enough Colonial detailing to be classified as examples of the Colonial Revival style. In Kirksville survey area the Minimal Traditional house was used as the major infill design during the 1940s and 1950s. In Kirksville houses of this vintage often have horizontal two-over-two windows. Porch supports are decorative metal and the porch deck is often poured concrete. The design was aimed at easing production and cost. In some examples the design is based on four-foot increments to allow for less cutting of sheet material.

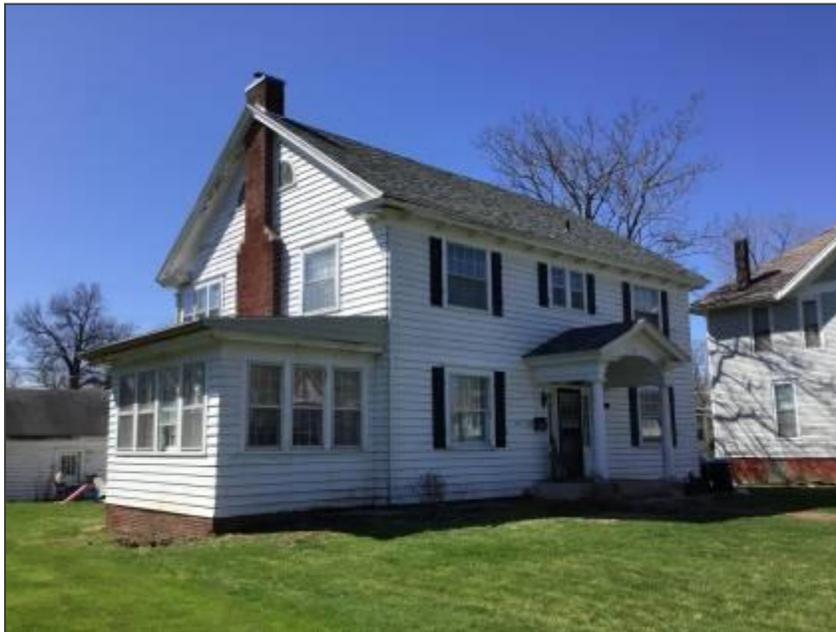
Figure 35. Colonial Revival Style (704 E. Harrison).

A revival of early American Colonial architectural forms emerged after the 1876 centennial celebration, and went through various waves of development through the 1950s. Early Colonial Revival often involved the application of Colonial visual features such as Tuscan Doric columns, fanlight windows, and bracketed cornices to houses reflecting the asymmetrical massing of the older Queen Anne style, or to simple folk or urban housing forms like the gable front or gabled ell. Post-1910 Colonial Revival homes often tried to more closely emulate original Colonial-style buildings, and often have more symmetrical facades and more accurate and academic use of Colonial detailing. Finally, starting in the 1920s and continuing into the 1950s, small modest Colonial Revival houses were built with simple architectural forms and sparse ornamentation. The survey area has a fairly small number of Colonial Revival houses. Most are medium-sized two-story houses and only a few examples of smaller Colonial Revival cottages were found in the survey area. While in some cities and suburbs much of the postwar infill housing was Colonial Revival in style, Kirksville builders working in the study area seem to have favored the more stripped-down Minimal Traditional style, or the modernist-influenced ranch, for postwar infill housing.

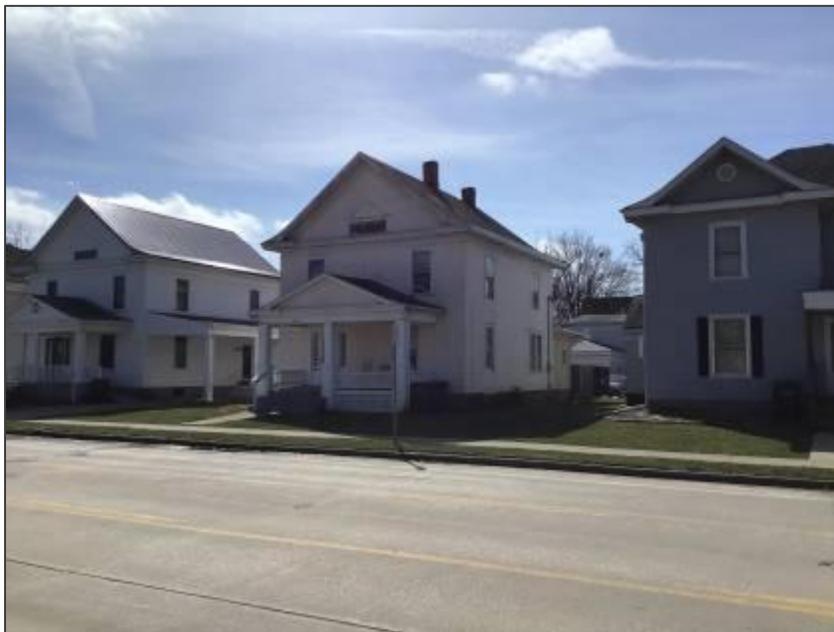
Figure 37. Classical Revival Style (406 E. Jefferson).

This style involves the revival of various classical architectural forms. Classical Revival houses are often symmetrical in form, and the ornament focuses on elements of Classical architectural grammar such as columns, bracketed cornices, entablatures, and pediments. The symmetry of the Classical Revival is in contrast to earlier Victorian styles like Italianate and Queen Anne that emphasized asymmetry, breaking up facades into smaller elements, and dense application of details and patterned elements. More elaborate Classical Revival examples follow classical models fairly closely, while the more common examples engage in more sparse use of classical elements. The style originated with a revival of classical forms in the 1880s by architecture firms like McKim, Mead, & White, and persisted well into the twentieth century. Since both Classical Revival and Colonial Revival use common elements like bracketed cornices and classical columns, modestly detailed examples of the two styles can appear similar. Most examples of the style in the Kirksville study area were common housing forms like the two-story gable-front that had modest amounts of classical architectural features applied. The photo below shows one such house.

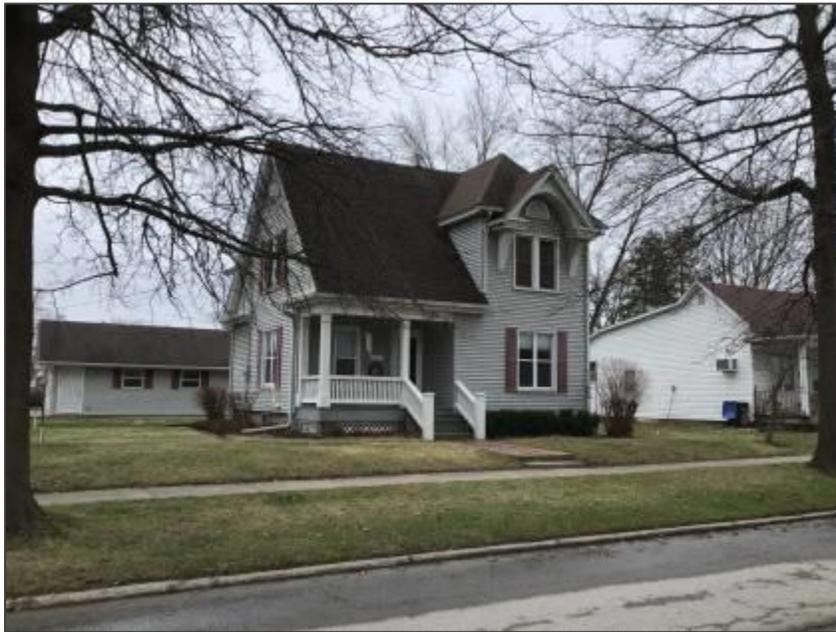
Figure 38. Late Victorian Style (624 E. McPherson).

The houses categorized as Late Victorian in the survey are typically wood-frame homes with somewhat complex, sometimes asymmetrical exteriors, and some stylistic ornament. The form and decoration of the houses is simpler than earlier Queen Anne and other High Victorian houses. However, these Late Victorian houses also do not have enough Classical or Colonial features to be classified as examples of Classical Revival or Colonial Revival. They also do not represent examples of traditional gable front, center gable, or gable and wing folk housing formats, and thus are not really examples of Folk Victorian. Many are examples of the common urban gabled-ell housing format, with only modest Victorian detailing on the porch. Or, for example, the house illustrated below has the overall form of a side-gabled bungalow, but the tower-like construction on the right side of the house with its large arched hood, gives the house a feeling of Victorian asymmetry.

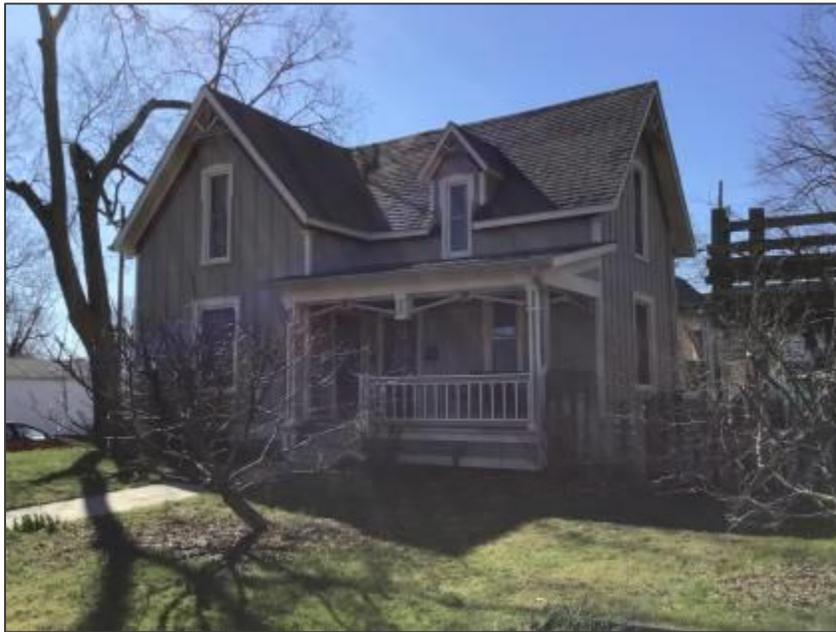
Figure 39. Gothic Revival Style (516 E. Harrison).

This is a fairly rare architectural style in Kirksville, appearing mostly in the context of churches and a very small number of homes. The style originated with the revival of interest in Medieval architecture in Europe, and especially England. Gothic Revival buildings generally have vertical proportions, steep rooflines, asymmetrical compositions, and Gothic ornamental elements including tracery, pointed arched windows, and thin, vertical columns. In the project survey area, two churches were built in this style. Trinity Episcopal Church is a high-style example combining Gothic and English Arts and Crafts elements. The second example, Mary Immaculate Church, is a later stripped-down version of the style combining modest Gothic elements with a Modernistic simplicity. The main example of Gothic Revival housing in the city is 516 E. Harrison, an example of Kirksville's ubiquitous gable and wing house format, but with steep rooflines and a porch decorated with unusually elaborate Victorian Gothic wood tracery.

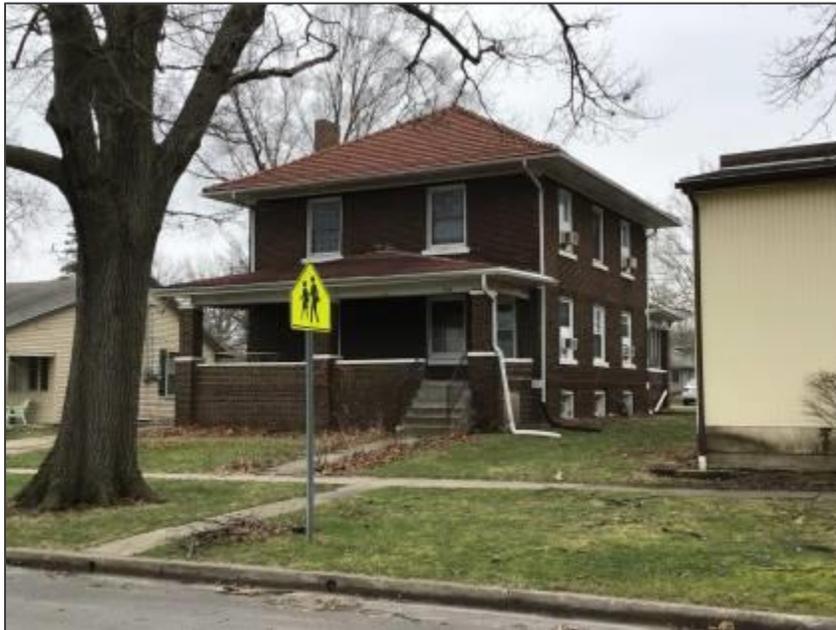
Figure 41. Foursquare Based on Prairie School Precepts (606 E. Washington).

Prairie School-style houses, usually manifested as American Foursquares, are not common in the survey area. While the design and style were wildly popular in parts of the country, the style was eclipsed by Craftsman style in the survey area. Most houses with Prairie influence are examples of the common American Foursquare type. Some of these houses are plain and convey the simple Prairie School spirit, while a few examples are decorated with stylistic elements reflecting more ornate and traditional architectural styles such as Colonial Revival.

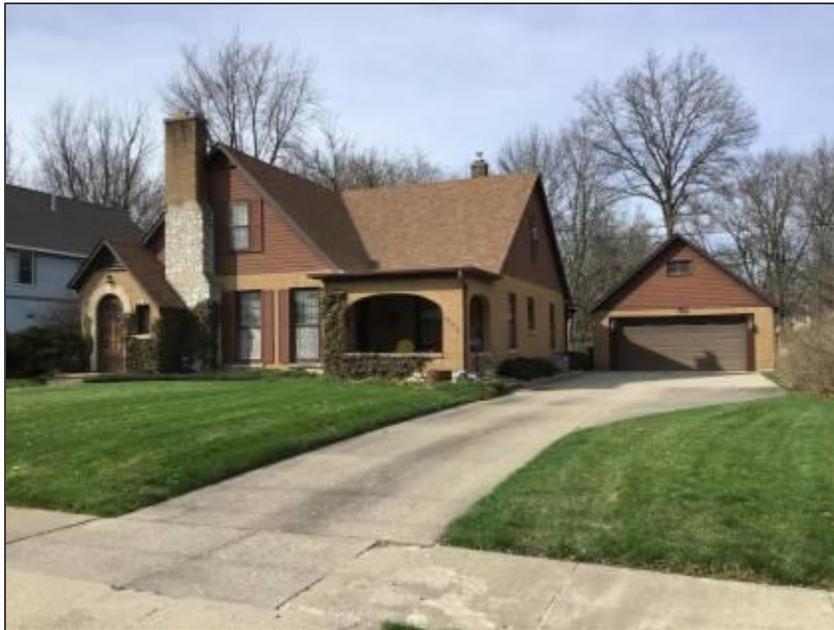
Figure 42. Tudor Style (805 E. Harrison).

Tudor-style homes are not common in the survey area. Only two examples were recorded and both are located on Harrison Street in the Old Town neighborhood. This is likely a result of the fact that by the time the style was in vogue most of the area was already built out. The Tudor Revival style is based on English Medieval architectural elements. Characteristics are asymmetrical facades, use of a mixture of brick, stucco, and half-timbered textures, leaded glass, and steep roof pitches. This style was only sparsely used in Kirksville; the city's residential builders appear to have favored the Colonial Revival and Craftsman styles instead.

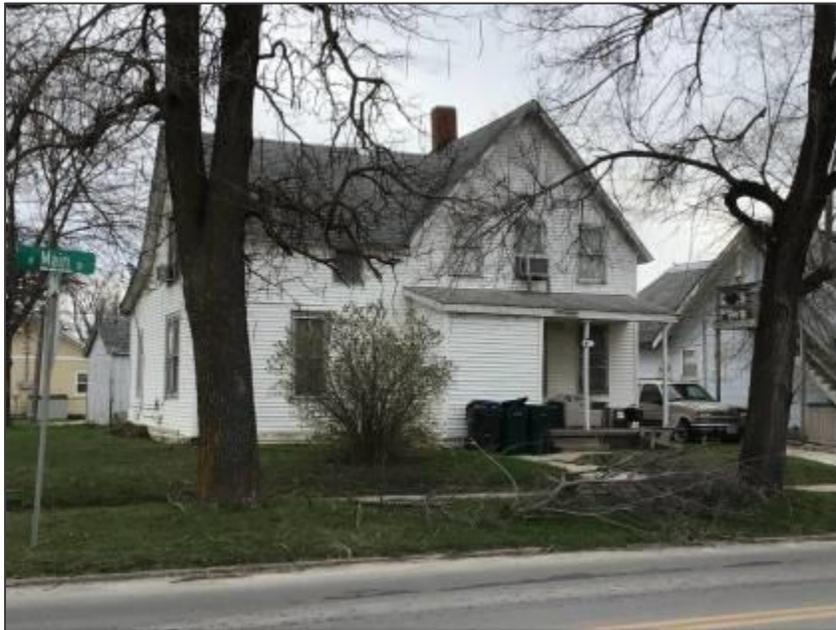
Figure 43. Folk Victorian Style (614 N. Main).

The term Folk Victorian refers to houses of traditional folk form that were decorated with somewhat modest Victorian trim, including porch spindle work, turned posts, and jigsaw-cut tracery. This ornament was commonly applied to houses of common and relatively simple folk architecture formats. Most often, this decoration was manifested on the front porch, with turned posts and decorative spindlework being the most common details. Houses with heavier stylistic detail were classified as examples of the Queen Anne style.

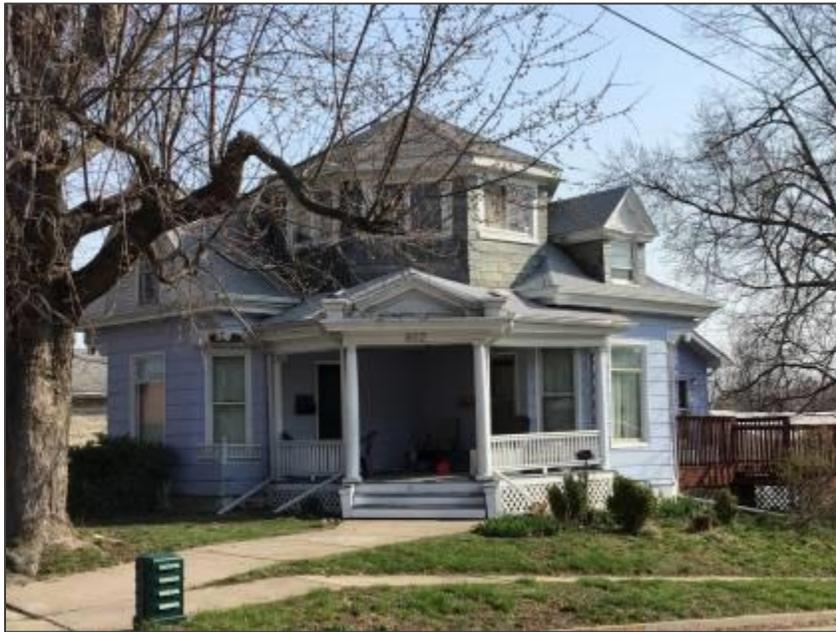
Figure 44. Eclectic Style (802 N. Franklin).

The term “eclectic” is often applied to a variety of architectural styles from the 1880s through the 1940s that revived past architectural styles. The sub-styles within the movement are often termed “revivals”—for example, Colonial Revival. Ornament from these styles was sometimes used on the same standardized building type to give different examples a somewhat different feel. For example, a post office of standard plan might be decorated in Colonial Revival or Spanish Revival, depending on what area of the country the building was being built in or on the architectural preferences of the community. Although Colonial Revival can be grouped under “eclectic” styles of the nineteenth and twentieth centuries, it is such a major architectural movement in the United States that it is given its own section in this discussion.

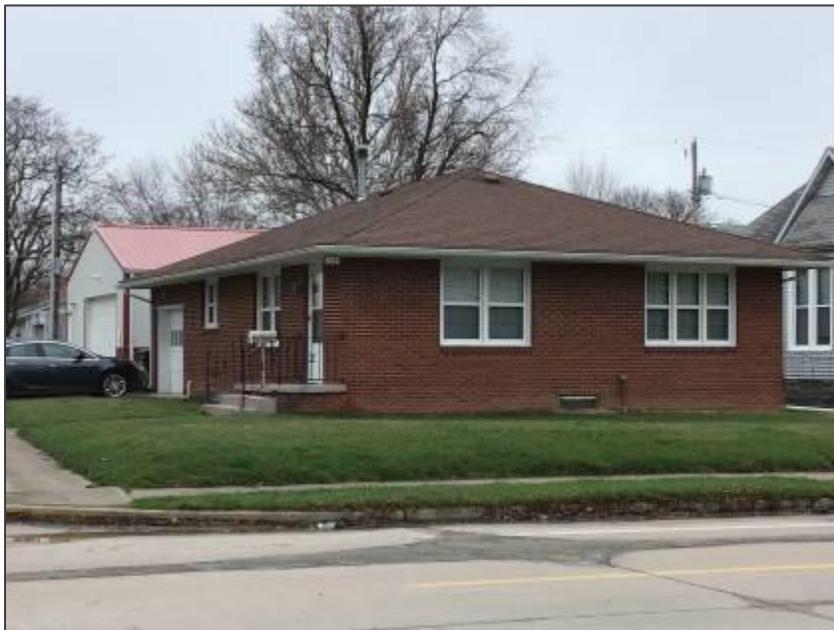
Figure 45. Mid-Century Modern Style (601 E. Jefferson).

These fairly broad terms cover any building with an architectural style and form mostly influenced by twentieth-century modernism. In general, modernism emphasizes exposure of structural elements, honest use of construction materials, elimination of ornament, and an embrace of mass produced and industrial materials and forms. Often cubic geometrical forms were favored over traditional gabled compositions used in earlier architecture. In the Kirksville survey's project area, influence of the modern movement is most commonly seen in the stripped-down cubic forms of commercial and industrial buildings, or in the horizontal, sprawling format of the 1950s–60s ranch houses. The project area also contains a modernist church, Meadowbrook Christian.

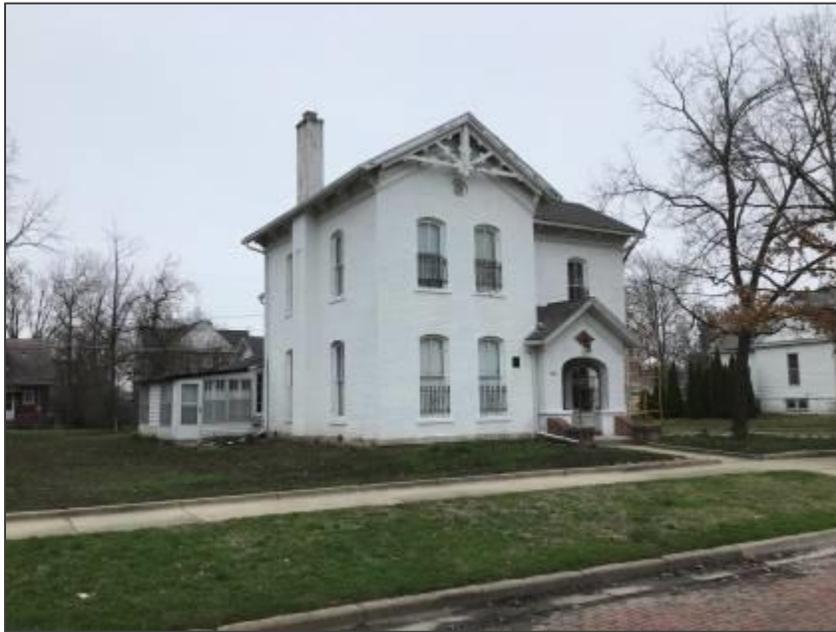
Figure 47. Italianate Style (415 E. Washington).

The Italianate style reflected a nineteenth-century interest in the architectural forms of medieval Italian villas. Hallmarks of the style are bracketed cornices, hood molds or pediments over doors and windows, long narrow windows, pyramid-roof towers, and tall, vertical proportions. Building facades are often asymmetrical, but also often have elements of symmetry. The style hit its height of popularity from the 1850s–80s. Most of the Kirksville survey area for this project was built after 1890, so Italianate houses are not common.

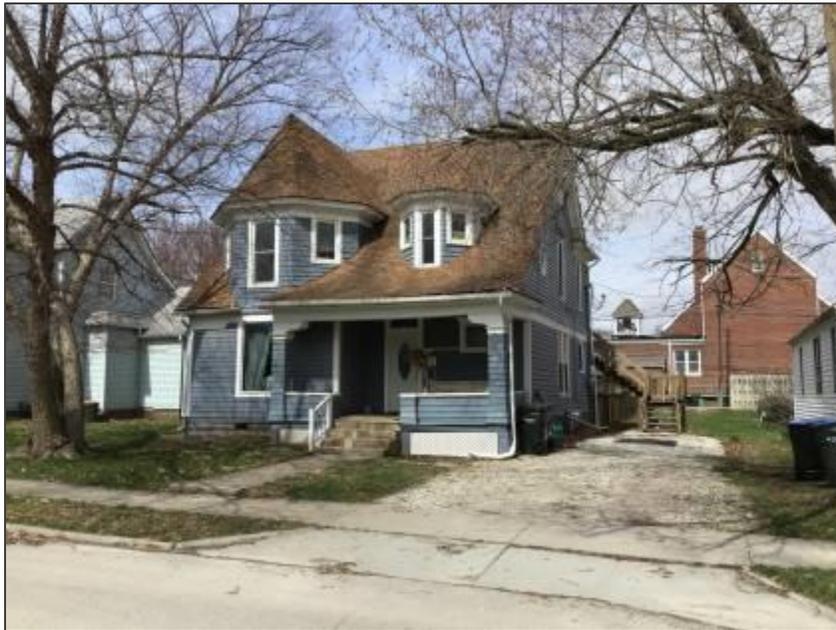
Figure 48. House with Elements of Shingle Style (703 E. McPherson).

This style originated on the east coast with the houses of McKim, Mead & White. The style took inspiration from simple New England folk architecture. The buildings were restrained in use of ornament and their distinguishing feature was the use of large flat or curved surfaces covered with wood shingles. Interesting roof forms such as multiple gables or gambrel roofs were often used to give the buildings visual interest, since they were otherwise fairly plain. Although no high-style shingle-style houses were found in the survey, some early twentieth century houses in the Kirksville study area show the style's influence.

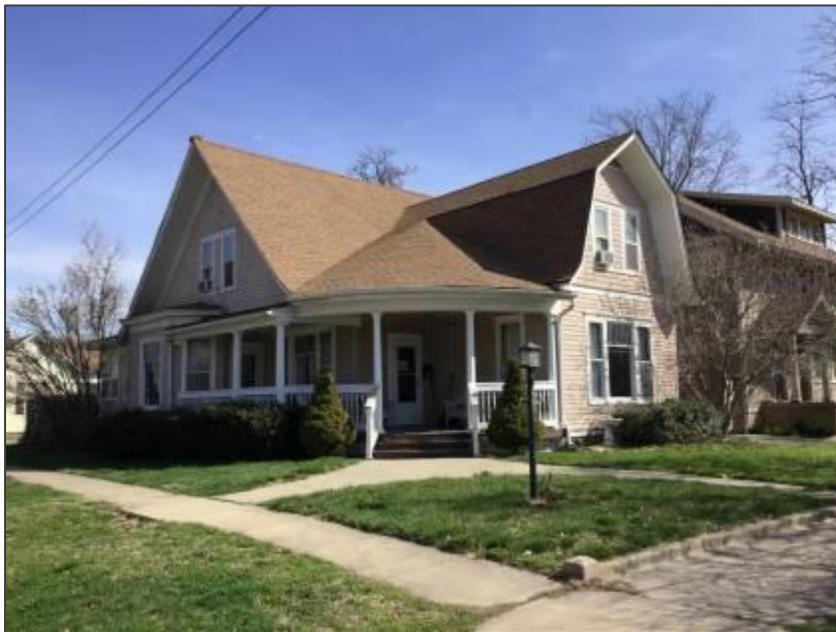
Figure 49. Dutch Colonial Revival Style (401 E. Harrison).

In American twentieth century housing, this term refers to houses that have normal Colonial Revival features such as Tuscan Doric columns and bracketed cornices, but that also have a gambrel roof. The gambrel roof has four pitches and is what most people think of as a “barn roof.” The Dutch Colonial can have the gambrel roof in a side-gabled or front-gabled format. The form was developed as part of high-style nineteenth-century houses built on the east coast by firms like McKim, Mead & White. In terms of normal Midwestern urban and suburban housing, the style appears most commonly in the 1920s, with many 1920s suburban subdivisions having multiple examples. However, only one example was found in the survey area in Kirksville.

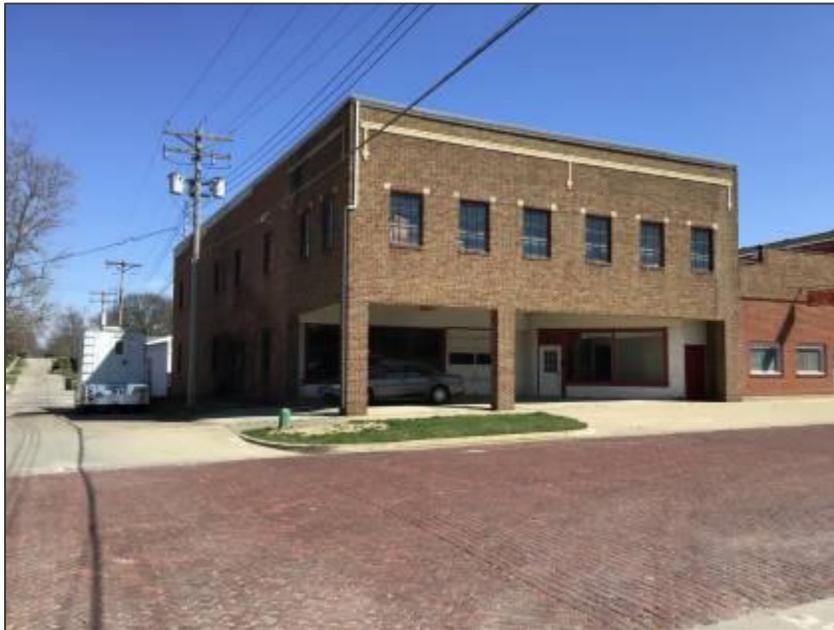
Figure 50. Chicago Style (514 N. Franklin).

This style reflects the development of early modernism in the Chicago School of architecture, influenced heavily by eminent Chicago architect Louis Sullivan, but also reflected in the work of other influential architects such as Albert Kahn. The main principle of the style is exposure of the structure of the building on its exterior. Ornament is used, as long as it does not hide or otherwise obscure the expression of the building's structural form. In industrial manifestations of the style, large steel windows and monitor-type skylights are used to get natural light into the buildings. Concrete framing elements with brick veneer walls are common textural materials on Chicago School commercial and industrial buildings. In Kirksville, use of the Chicago Style is limited to some of the city's commercial and industrial buildings.
