Reconnaissance Survey of the Depot District and Old Town Neighborhoods

Kirksville, Adair County, Missouri

Owen & Eastlake Ltd.

City of Kirksville, Kirksville, Missouri

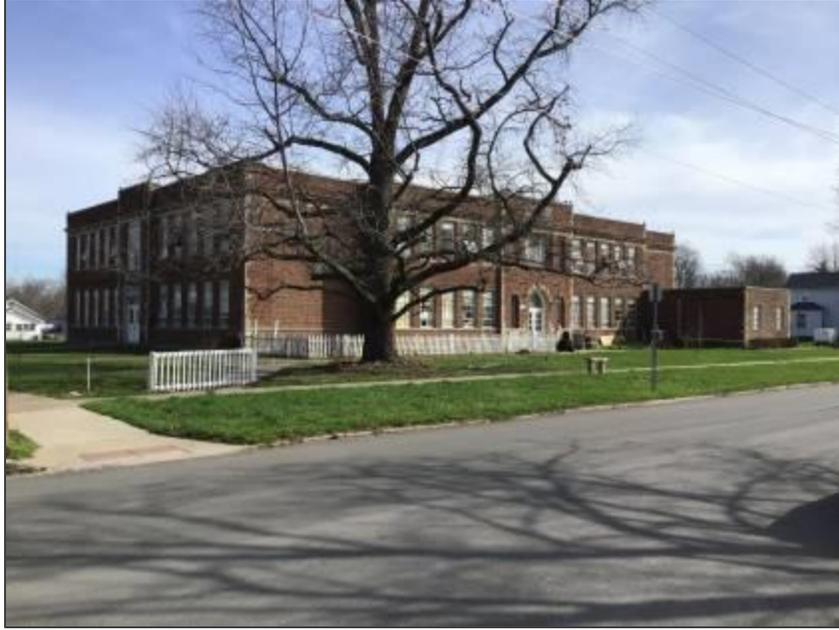
Figure 51. Chicago Style (Washington School, 509 E. Harrison).

This style reflects the development of early modernism in the Chicago School of architecture, influenced heavily by eminent Chicago architect Louis Sullivan, but also reflected in the work of other influential architects such as Albert Kahn. The main principle of the style is exposure of the structure of the building on its exterior. Ornament is used, as long as it does not hide or otherwise obscure the expression of the building's structural form. In industrial manifestations of the style, large steel windows and monitor-type skylights are used to get natural light into the buildings. Concrete framing elements with brick veneer walls are common textural materials on Chicago School commercial and industrial buildings. In Kirksville, use of the Chicago Style is limited to some of the city's commercial and industrial buildings.

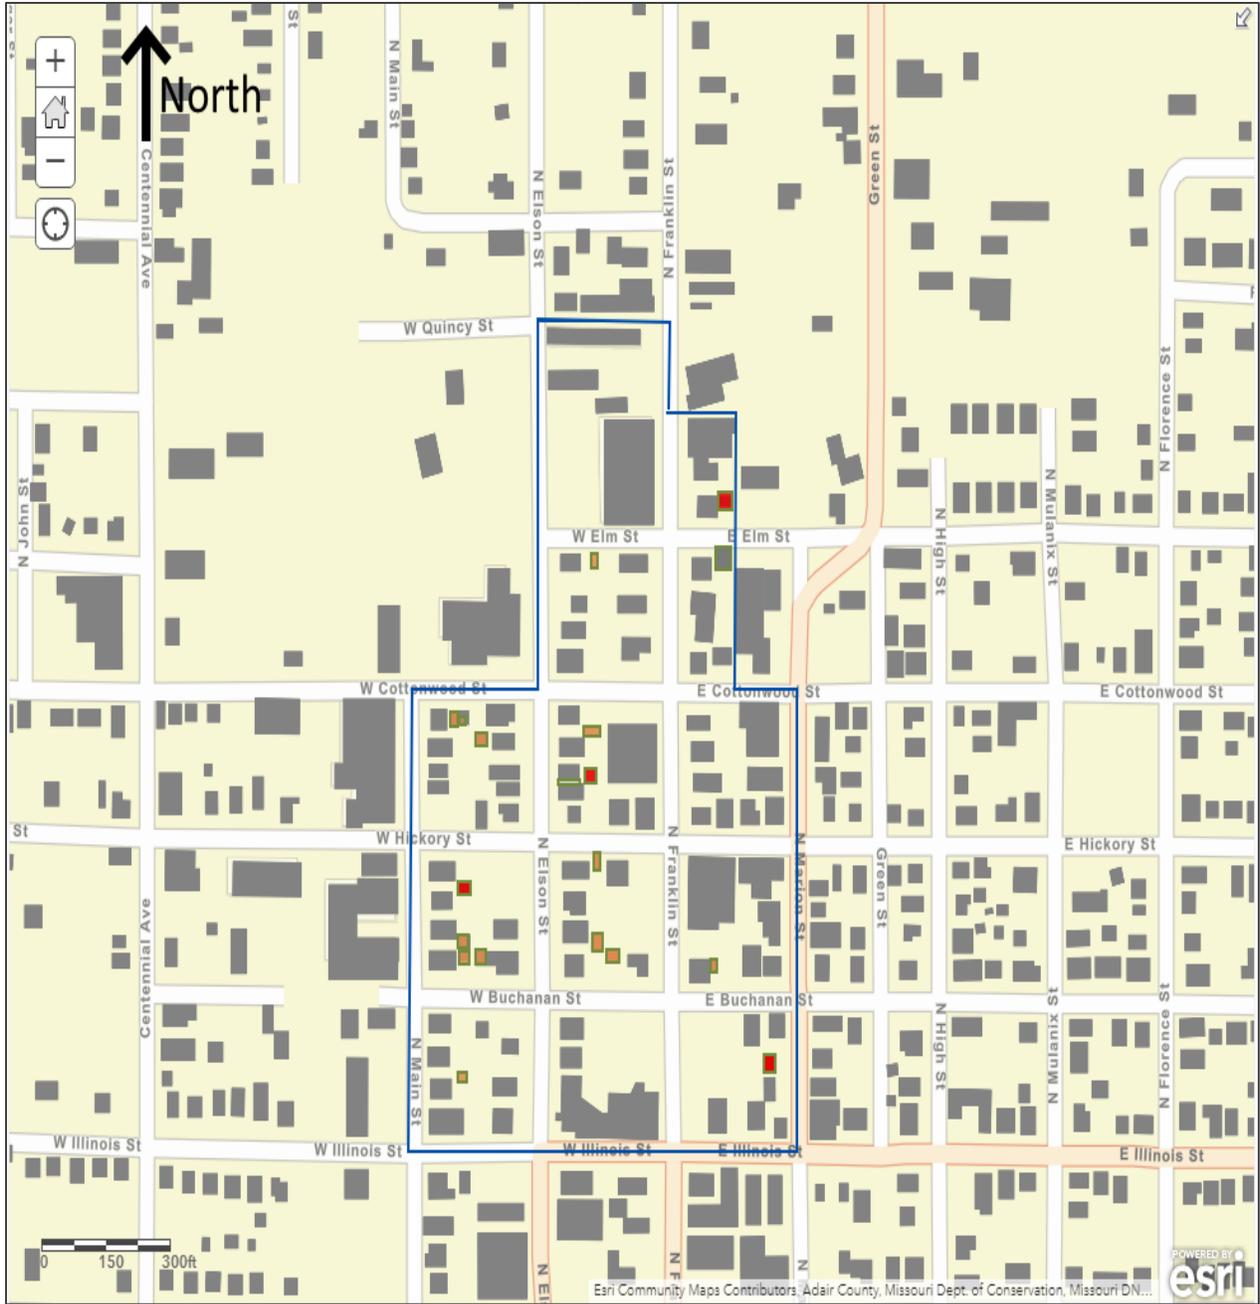
Figure 52. Map: Inventoried Outbuildings, Depot District.
 Orange outbuildings are historic. Red outbuildings are modern or altered.

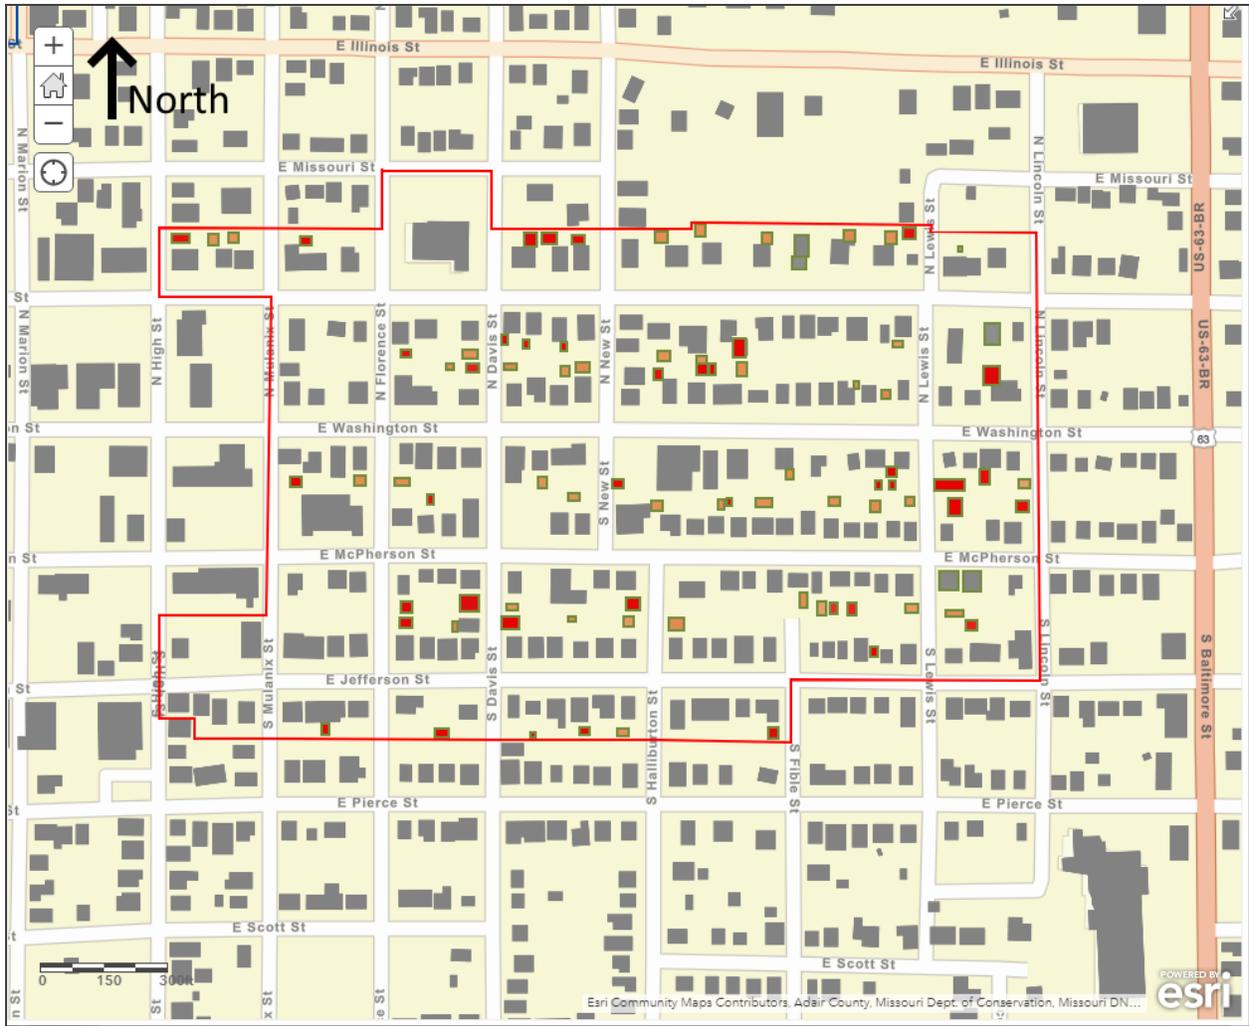
Figure 53. Map: Inventoried Outbuildings, Old Town Neighborhood.
 Orange outbuildings are historic. Red outbuildings are modern or altered.

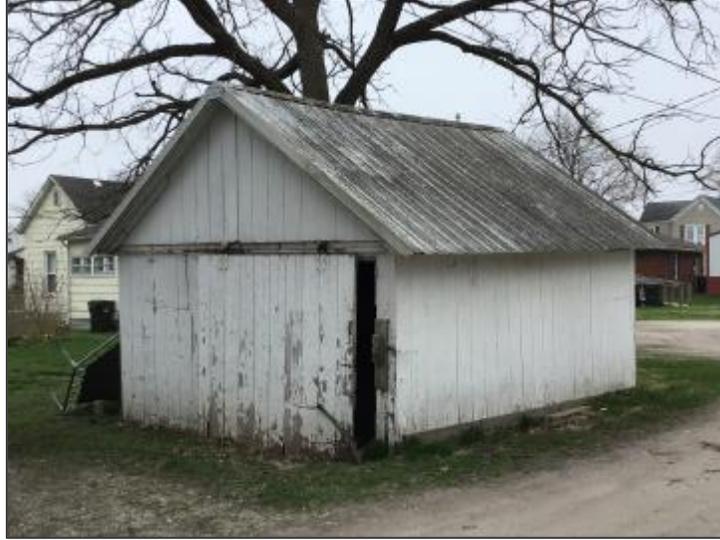
Figure 54. Pre-1925 Vertical-Sided Garage (615 E. Jefferson).

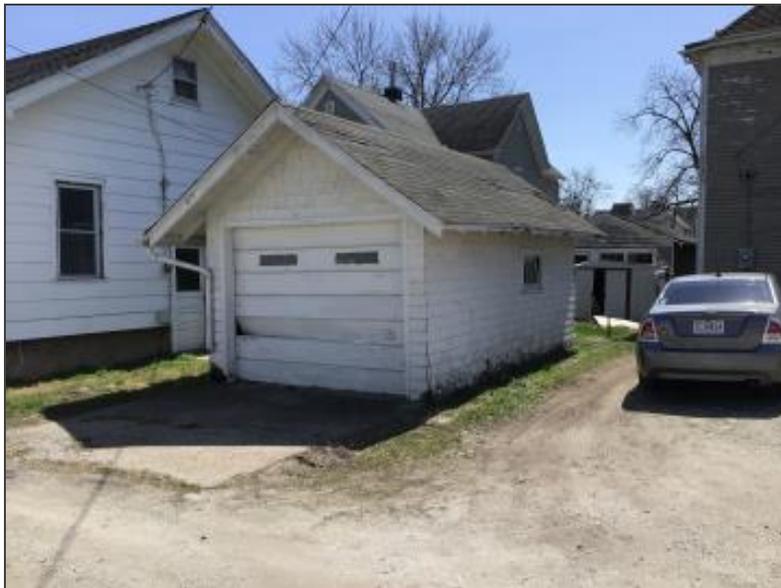
Figure 55. Garage with Exposed Rafter Tails (210 S. Davis).

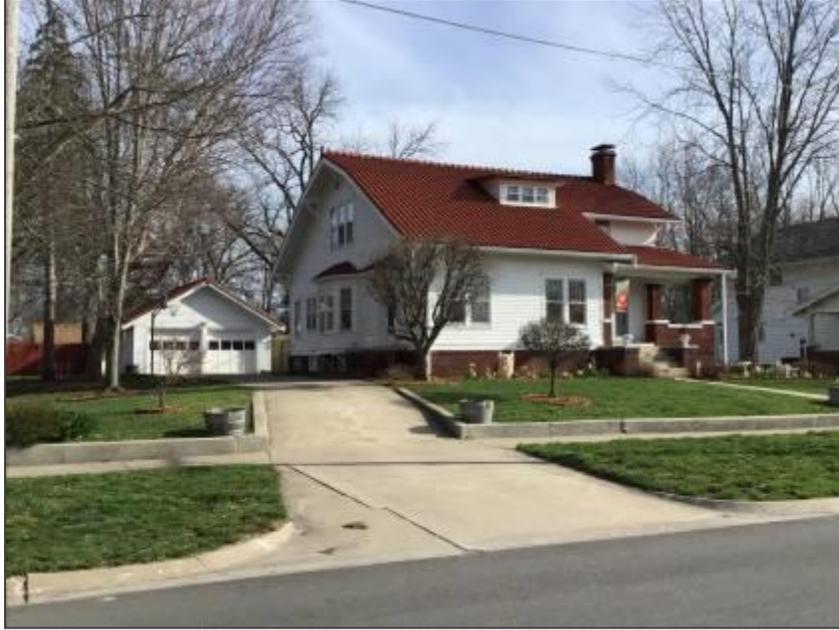
Figure 56. House-Matched Garage (711 E. Harrison).

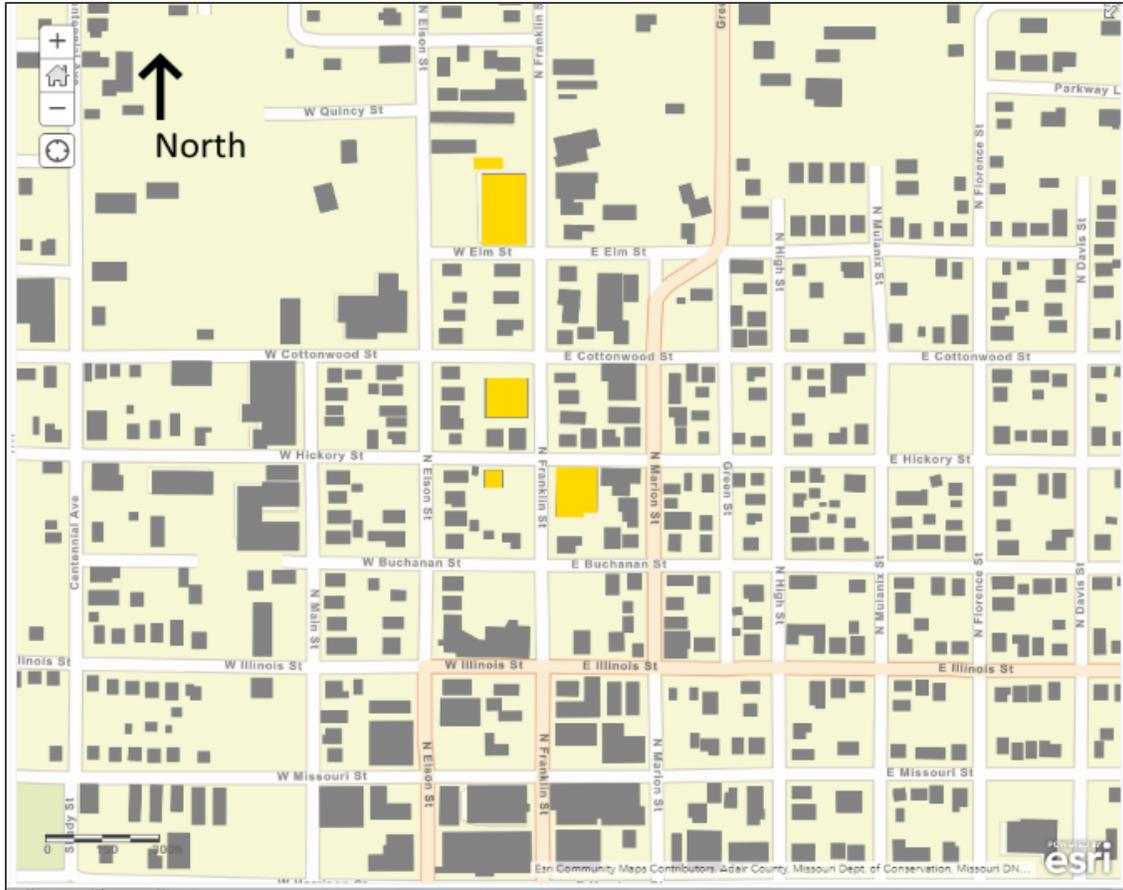
Figure 57. Map: Potential Automotive-Themed Franklin Street National Register District.
Automobile-themed buildings are marked in yellow.

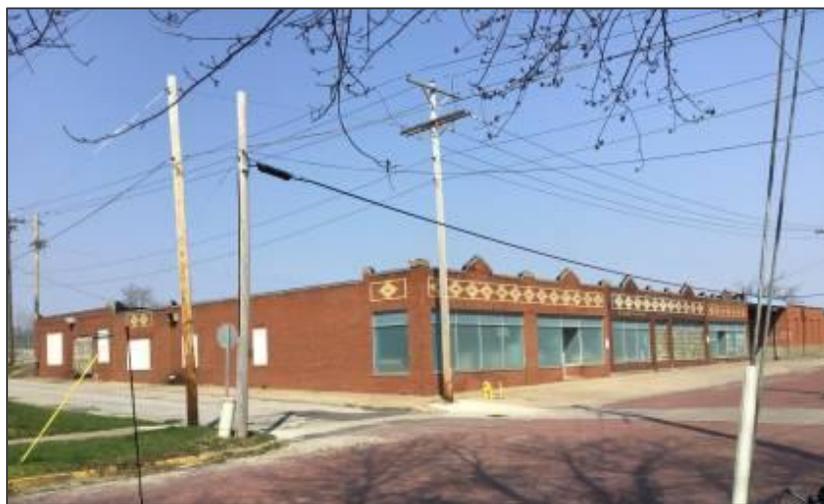
Figure 58. Burdman Building, Automobile-Themed Commercial Building (815 N. Franklin).

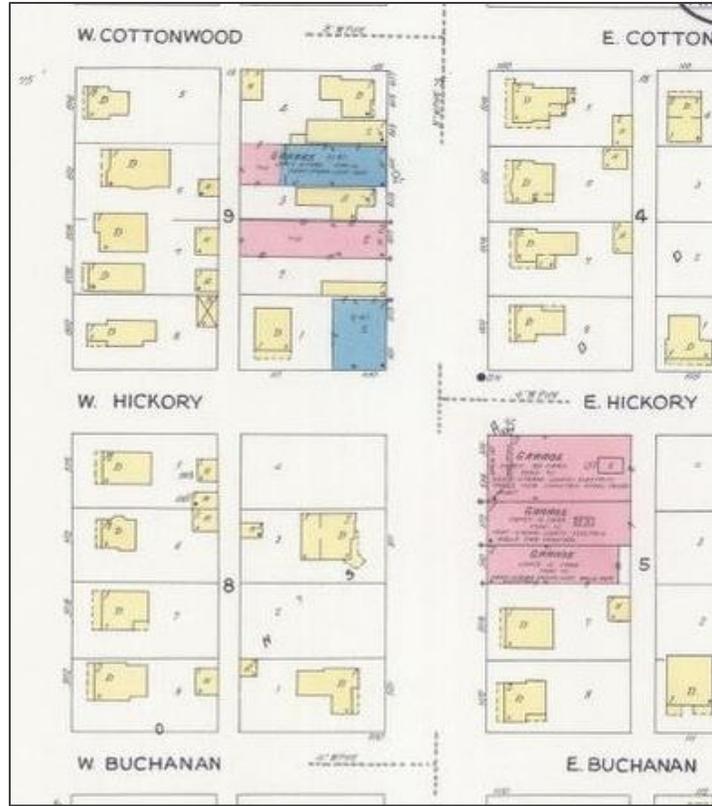
Figure 59. 1925 Sanborn Fire Insurance Map Showing Automobile-Themed Buildings along Franklin Street. Automobile-themed buildings are marked in pink. (Library of Congress)
